GEOTECHNICAL CHARACTERISTICS OF TERRAIN AND PROPOSAL FOR SANATION MEASURES OF LANDSLIDES SULJENDICI, MUNICIPALITY SREBRENİK

Durić Neđo¹, Imširpašić Kenan², Hadžiosmanović Alma², Đujić Anđa¹

¹*Technical Institute Bijeljina, Bosnia and Herzegovina, e.mail. nedjo@tehnicki-institut.com*

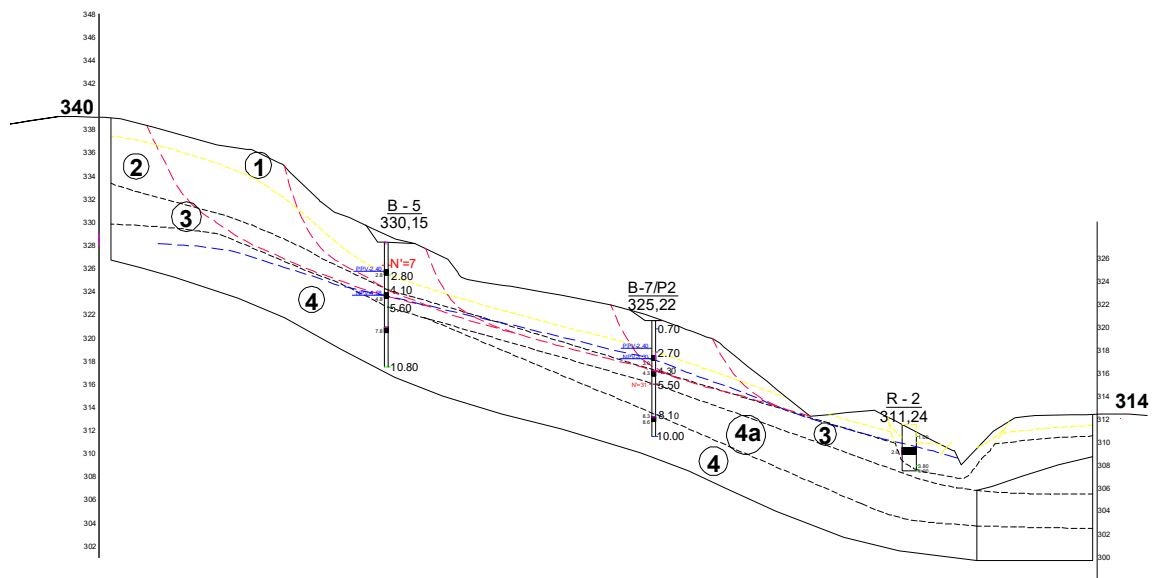
The area of landslide is build of clay sediments which observed in the vertical profile can be classified as colluvial diluvial sediments, layer 1, below which are reddish sandy silty clays with tiny fragments of rocks, layer 2, figure 2. Below these lie tuffites clays, layer 3, which are often interlayered with reddish and misty gray clays. Substrate of the terrain consists of degraded sandstones and conglomerates and clayey gravels and sands, layer 4. As part of the substrate at the bottom of landslide are allocated in the form of lenses, plastic sandy clays with fragments of rocks and gravel pebbles [4].

Figure 2. Engineering geological profile of terrain on landslide
 1, clayey sediments, 2, silty - sandy clay, 3, tuffites clay,
 4, sandstones and conglomerates, 4a, sandy clay

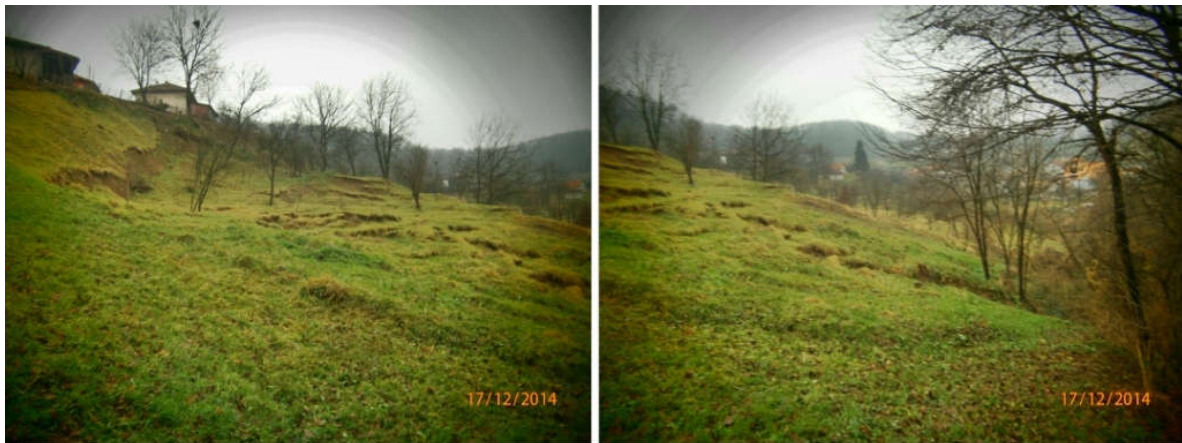
The biggest devastation of the terrain occurred in the central and eastern part of the slope ie at the bottom of residential buildings. Frontal scar is formed in the immediate vicinity of objects. The height difference between objects and beginning of sliding is around 2,0 – 3,0 m, and minimal distance in the horizontal direction is about 10 m, figure 3. The scar continually extends in the length of about 45 m, direction east - west. The height is about 1.0 m on the western side, in the area of facilities is about 2.0 - 3.0 m, while on the eastern side is lost on the local ridge between the the researched and neighboring slope. In the zone of the borehole B - 8 / P1 branches and a longer arm can be discerned all the way to the far east side of slope. Along scar length are registered washings, and in bottom part of the scar are present changes of small surfaces that are important for further development of sliding process, figure 3 .

Figure 3. Frontal scar and bottom part of slide

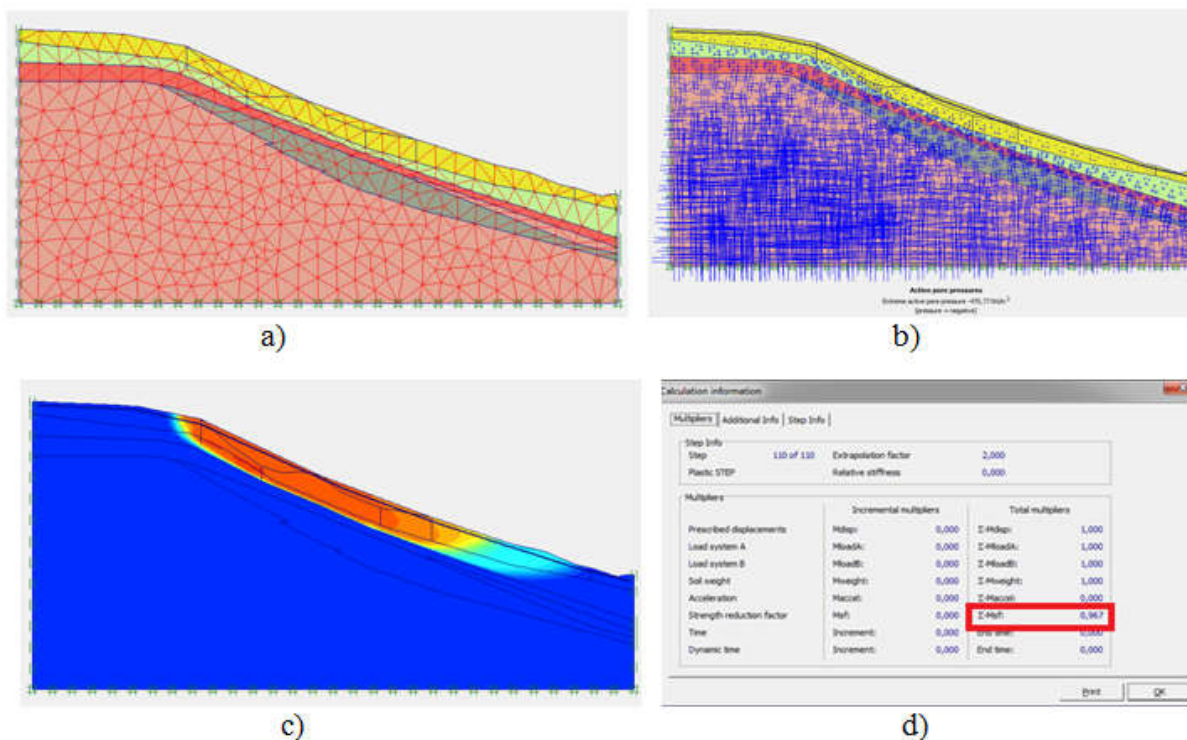
On profiles 1, 2 and 3 were made geotechnical models with selected parameters of soil whereby all layers of soil were completely saturated with water up to the line of terrain. For those conditions were obtained safety factors $M_{sf} < 1$ for critical sliding plane made with method c/φ reduction, which

indicates that the soil is not stable. The same confirm reality on the ground. Characteristical profile 2, is shown on figure 4.

Figure 4. Characteristic profile 2, stability analyzes

c) the potential sliding plane with a safety factor MSF = 0.967, d) part of the listing calculation

Proposals for sanitation measures relate to the controlled drainage - decreasing level of groundwater of entire site that is affected by sliding [9,12,13]. Drains will be brought from the zone of residential buildings to the stream at the bottom of the slope. Filling of drains is of crushed stone, to a depth of overtake of non moving parts of the terrain. Number and spatial position of drains should be placed in accordance with the calculation evidence of slope stability.

To stabilize the terrain is necessary to regulate the stream bed in the bottom of the slope, in the way that bottom part of the slope is ensured from eroding during the torrential waters.

Surface of sanitized slope regulate in terms of its inclination in order to achieve conditions for its quick and easy surface draining. Sanation works perform during the dry season, since the tuffites clays of layer 3 are expansive when soaked with water.
