Preliminary report
UDK 628.1/3:351.778.31]:551.24
DOI: 10.7251/afts.2022.1426.033T
COBISS.RS-ID 136083713

LANDSLIDE REMEDIATION ON LOCATION OF TRANSMISSION LINE POLE SM 134 ON DV 110 kV TS TUZLA C. – TS DUBRAVE

The aim of the paper is to show the landslide that damaged the transmission line pole, and its remediation. The landslide is located in Tuzla, and the microlocation of the facility is located in the area of the Dolina and the settlement of Vrapče. The remediation was made on the basis of a study on the characteristics of the terrain and the design of the basic structure of the pillar.

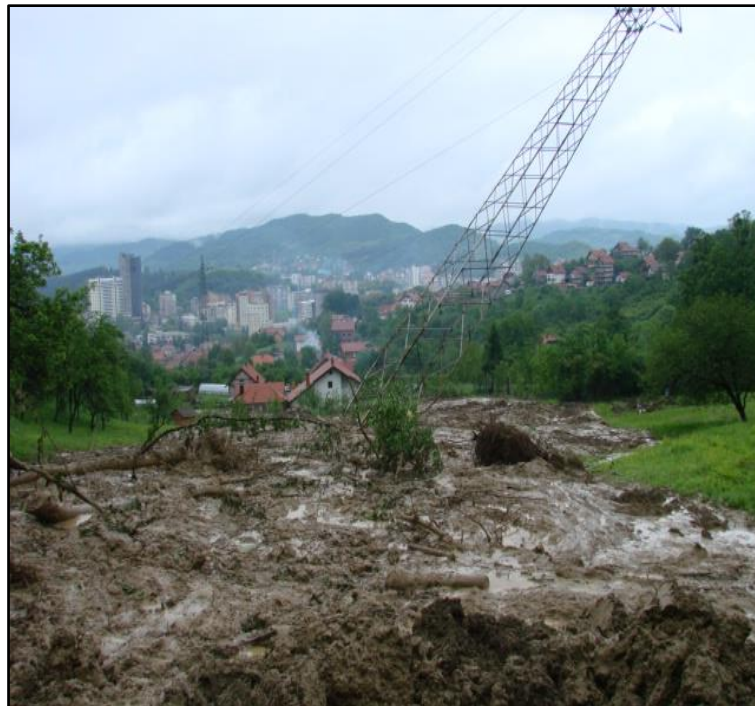
The microlocation of the pole site was determined by coordinates according to the Gauss-Krieger network: $x = 6554699,74$ and $y = 4931170,85$. Morphological conditions at the site are assessed as relatively favorable. In nature, it is a slightly steep slope, almost flat plateau, formed by erosion and denudation processes in the phase of the sedimentation cycle of the middle and lower Miocene. A visit to the site revealed the problem of landslides on the slope around and above the place where the pole should be based [2].

Figure 1 Ground situation after the landslide

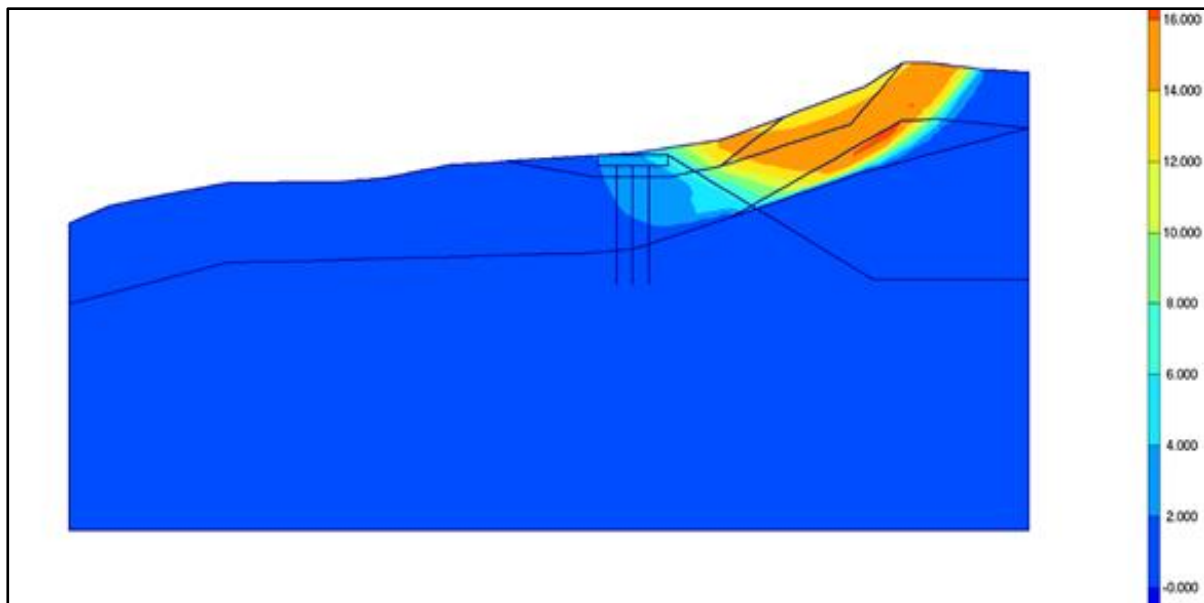
The calculation was performed on the most critical cross-sectional profile [7]. It is assumed that the landslide is in a state of boundary equilibrium, i.e., that the safety factor is $F_s = 1,000$. Figure 2 shows the most critical sliding surface in the natural state, obtained by calculation based on field and laboratory exploration, engineering geological determination and classification of exploration well core, as well as the results of feedback analysis. The following calculated soil parameters for selected geotechnical environments were determined: [3]

- For geotechnical environment cover materials GS 1: deformability modulus $E_s = 5$ MPa; bulk density $\gamma = 17,5$ kN/m³; internal friction angle $\varphi = 15^\circ$ and cohesion = 5, 5 kPa.
- For materials of geotechnical environment GS 2: modulus of deformability of rock mass $E_s = 250$ MPa; bulk density $\gamma = 20$ kN/m³; internal friction angle $\varphi = 23,5^\circ$; cohesion = 20 kPa.

Figure 2 Calculation of slope stability for natural condition $F_s = 1,000$

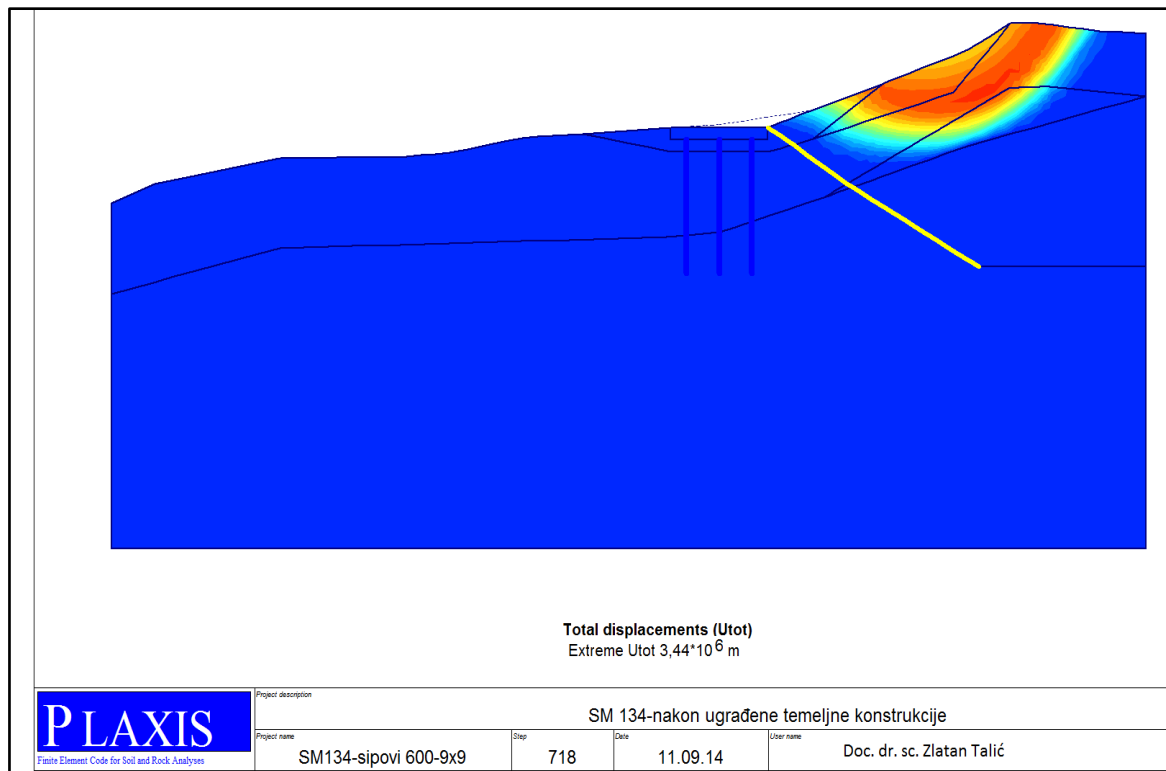
In the second phase of the calculation, the analysis of the remediated slope was performed and the safety coefficient $F_s=1,320$ was obtained. Figure 3 shows the most critical sliding surface of the remediated slope [3].

Figure 3 Calculation of slope stability for repaired condition $F_s = 1,320$ [3]

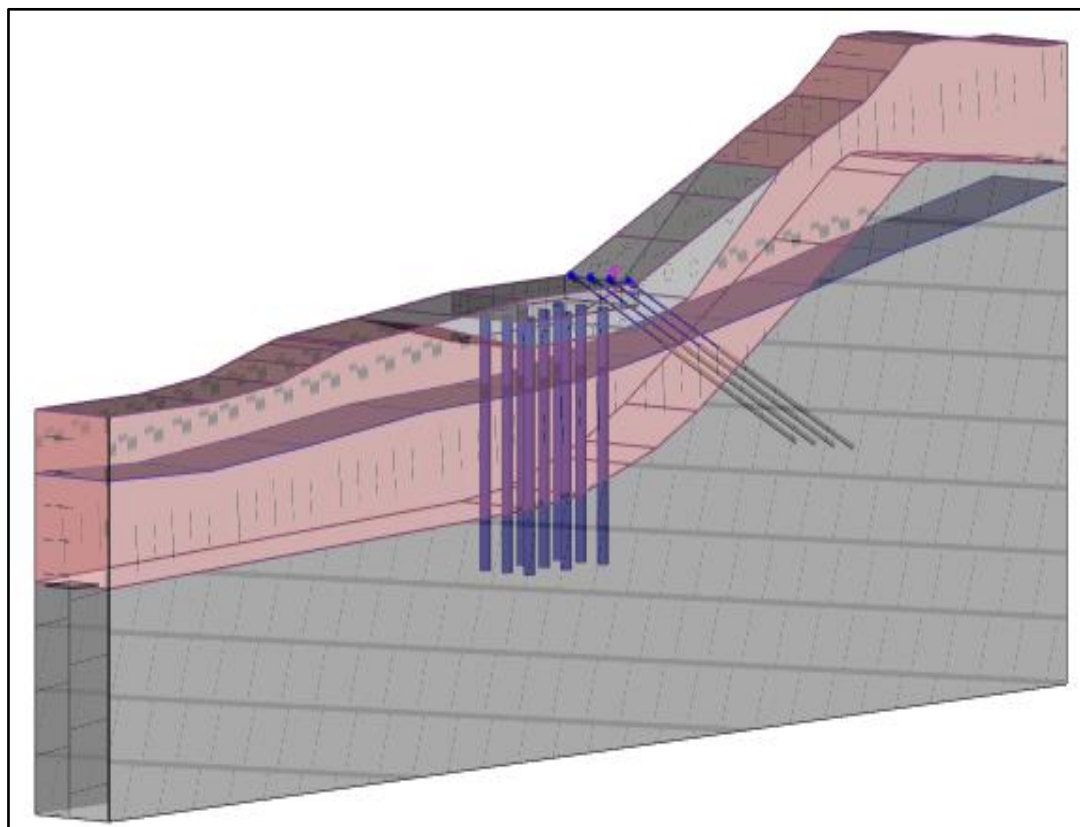
In addition to this calculation, a stability check was performed in the Geo 5 program for the same geotechnical terrain model and design solution. The calculation model in 3D is shown in Figure 4.

Figure 4 Calculation of slope stability for repaired condition in software Geo5

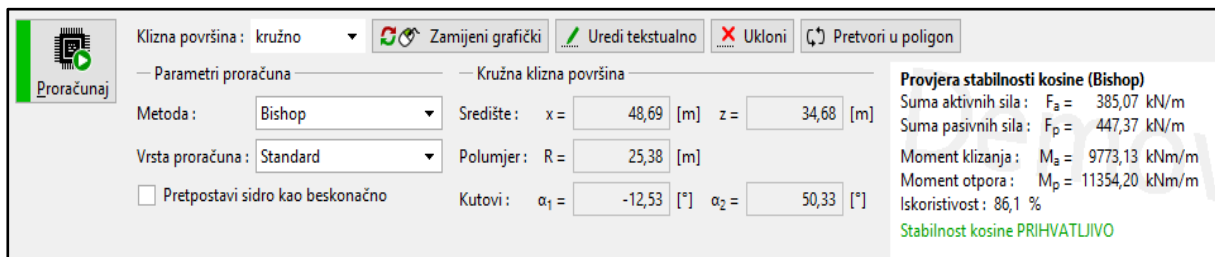
Results of calculation in Geo5 program.

The results in Geo5 program show that the slope is stable.

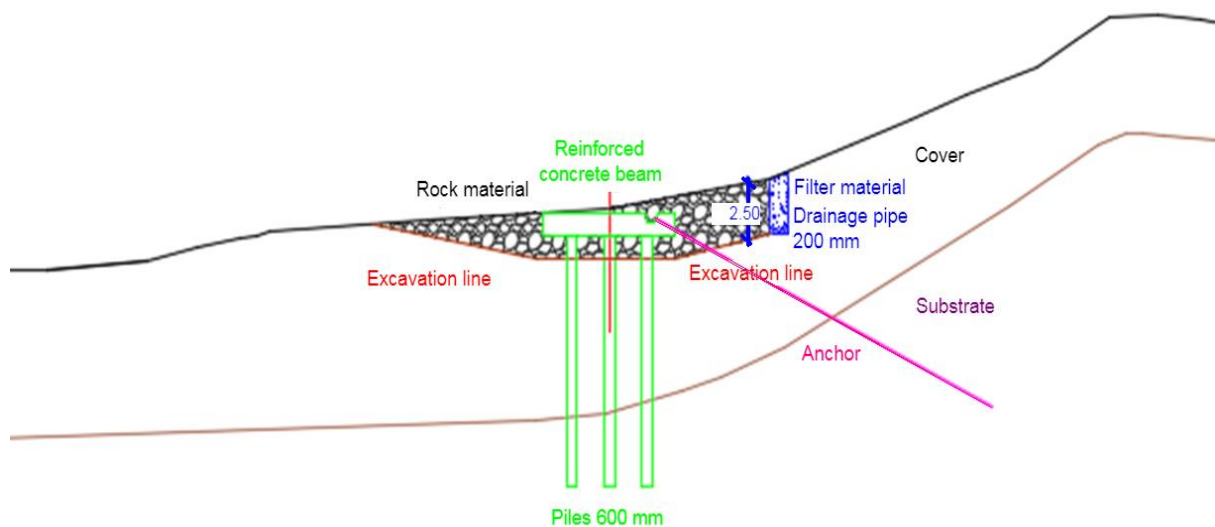
The solutions are shown in Figure 5 for normal transverse remediation profile.

Figure 5 Normal transverse remediation profile

- Drainage of the slope with a drainage channel placed in front of and above the place of foundation of the pillar and controlled drainage of the collected water through pipes and channels down the slope,
- Construction of 9 drilled piles of $\varnothing 600$ mm and 11 m long, provided that they must enter the substrate at least 3,00 m,
- Installation of stone material under the ground plane, approx. 1,00 m thick,
- Construction of a ground plane with measures 9.00 x 9.00 m and 1.00 m thick, which will connect and stiffen the piles,
- Installation of pre-stressed anchors, 20 m long, in the ground plane. The anchors must enter the substrate materials at least 12 m. The anchors are pre-stressed to a force of 250 kN
- Installation of stone material, as a supporting structure that will stabilize the slope above the foundation of the pillar
- Cleaning the existing culverts and gutters.

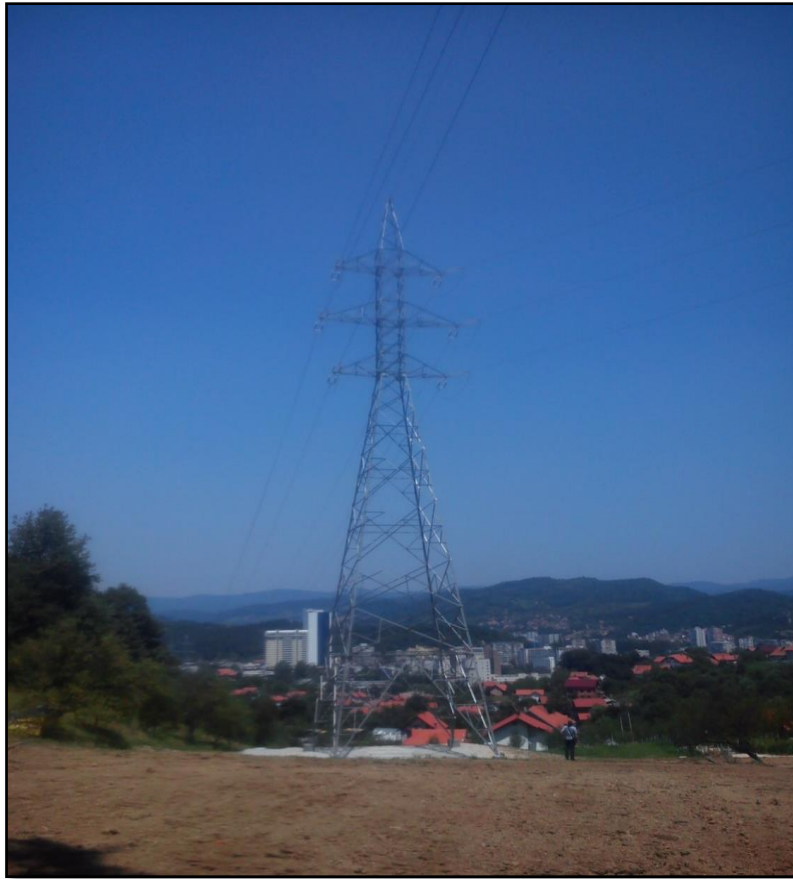
Based on the analysis of the problem at the location in question, the most optimal and safest solution for the remediation of the mentioned slope was given [3]. Figure 6 shows a picture of the terrain after remediation.

Figure 6 Image of the terrain after remediation
