LIQUEFACTION-INDUCED DAMAGE IN THE CITIES OF ISKENDERUN AND GOLBASI AFTER THE 2023 TURKEY EARTHQUAKE

Milev Nikolay¹, Takashi Kiyota², Briones Juan³, Briones Othon³, Cinicioglu Ozer⁵, Torisu Seda⁶

SUMMARY

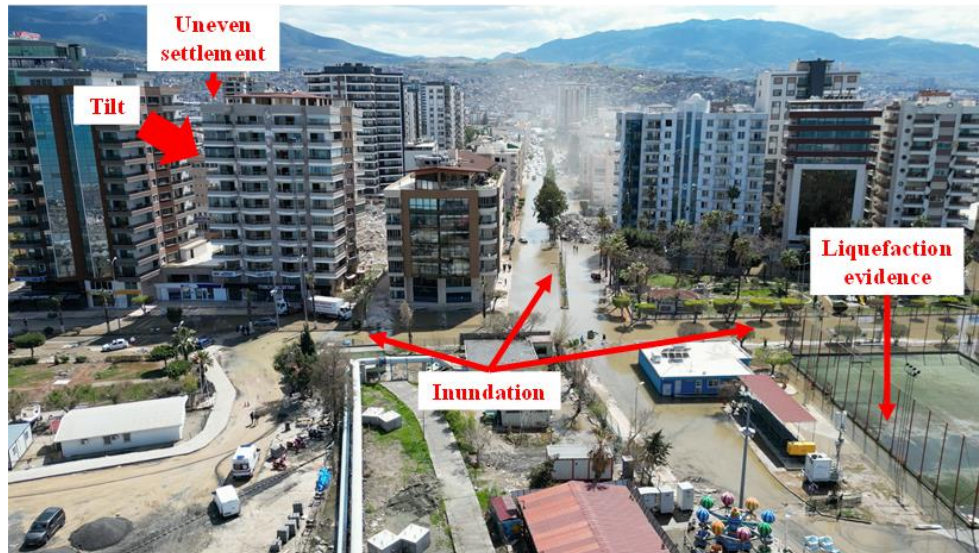
Figure 2 additionally illustrates damage caused by liquefaction, including slight building subsidence and significant sidewalk uplift. This street was previously a water channel [6], potentially making the reclaimed soil in the channel susceptible to liquefaction during the earthquake. Figure 3 and Figure 4 depict typical structural damage in Iskenderun. Figure 3 shows a mid-rise building in reclaimed land, where the entire structure has tilted significantly.

Figure 3. Evidence of various kinds of geotechnical problems observed in Iskenderun

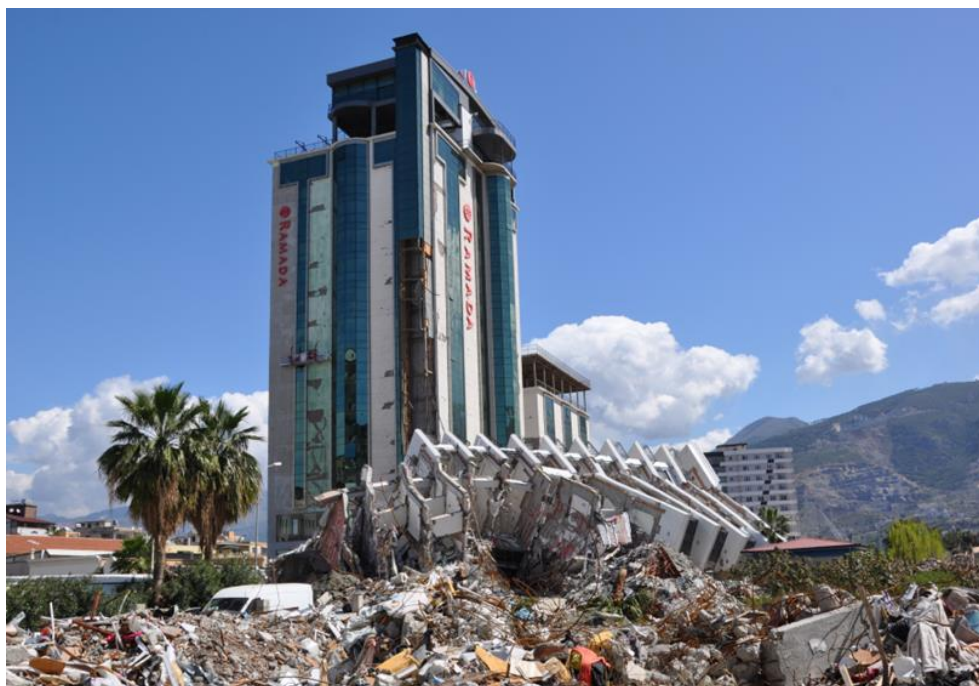
Figure 4. Collapsed building located in the former marshland – near Hotel Ramada

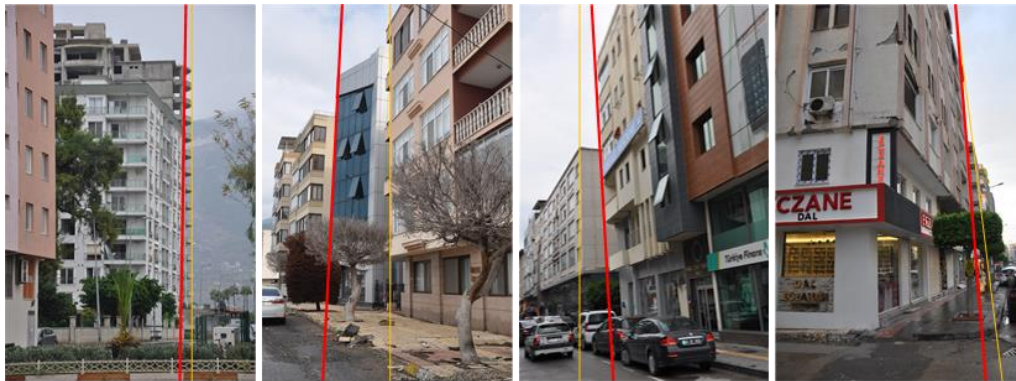
Similar damage, characterized by tilting and settlement of buildings, is evident along coastal streets, albeit to varying degrees (Fig. 5 and Fig. 6). This damage is likely attributed to liquefaction of the reclaimed ground and loss of bearing capacity. In contrast, the structure shown in Figure 4, located in an area formerly marshland, collapsed in a twisting manner. Information on the distribution of structural damage patterns in Iskenderun City is currently limited, but it is observed that there was relatively more structural damage due to seismic motion inland from the reclamation boundary. Both geotechnical issues and structural damage occurred in the marshland area. Different surface ground

characteristics and the presence or absence of liquefaction likely contributed to distinct patterns of structural damage.

Figure 5. Tilted middle-rise buildings near the sea-coast (at the beginning of the reclaimed land)

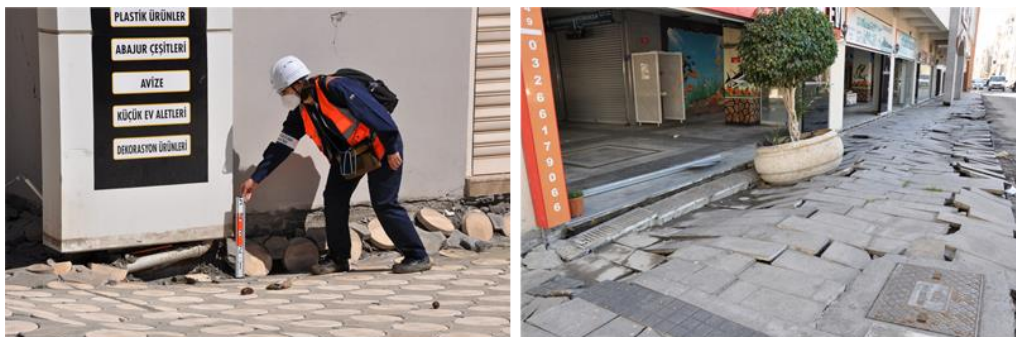
Figure 6. Settlement of buildings due to soil liquefaction

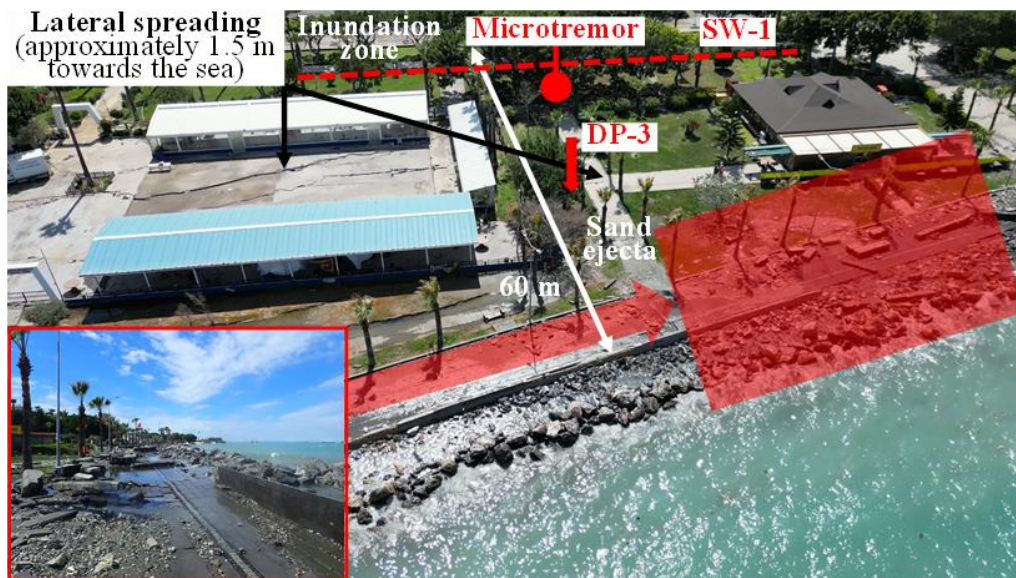
Figure 8 illustrates the reclaimed area where the promenade along the seashore subsided significantly, by approximately 50 centimeters, nearly aligning with the sea level. This subsidence likely led to the inundation of coastal streets by high waves. Observations also noted water flowing backward and emerging from sewage manholes on the inundated coastal street. The blockage of sewage pipelines due to liquefied soil deformation likely caused extensive inundation damage.

Figure 7 presents the exact location and Figure 11 results of the PDCPT at DP-3 and the multichannel analysis of surface wave (MASW) at SW-1. The PDCPT was conducted down to a depth of ground level -4.0 meters, revealing that the groundwater table was almost at the surface. The N_{SPT} values at the top surface were consistently low, less than 5, and slightly increased, ranging from 5 to 10, from ground level -1.0 meter to -2.0 meters. Below this depth, the soil layer exhibited loose characteristics, with N_{SPT} values averaging around 5. As shown in Figure 8, several cracks, each several tens of

centimeters wide, were identified in the reclaimed land due to lateral spreading, and numerous sand ejecta were observed, indicating that coastal area land subsidence was induced by liquefaction. Calculating the distance of cracks from the seashore to be 60 meters inland, the lateral displacement was estimated to be as much as 1.5 meters toward the sea.

Figure 8. Liquefaction-induced damages in the reclaimed land (36°35'33.99"N, 36°10'6.98"E)

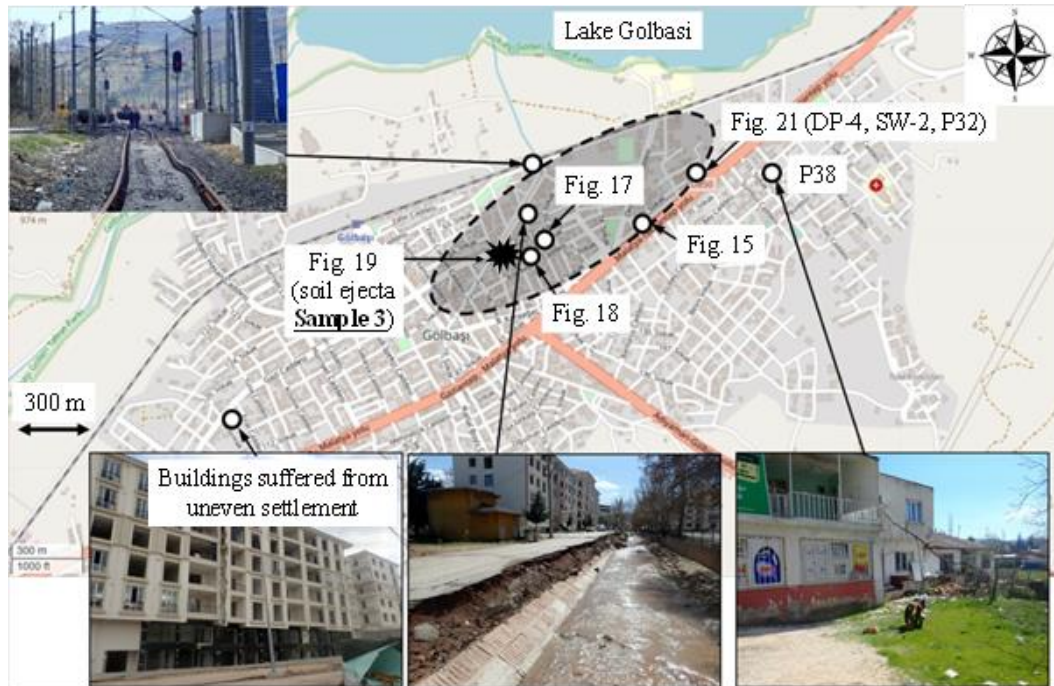
Figure 14. Extent of the liquefaction-induced damages in the town of Golbasi

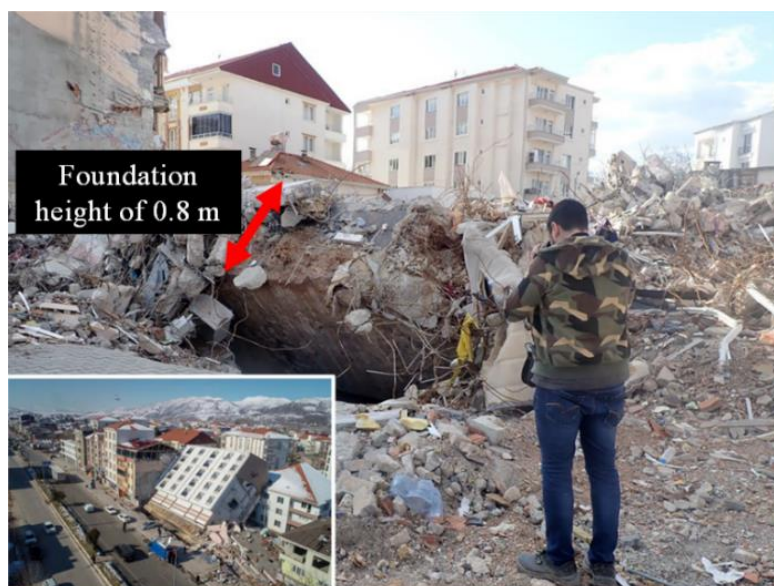
Figure 15. Tilted foundation of demolished building [5]

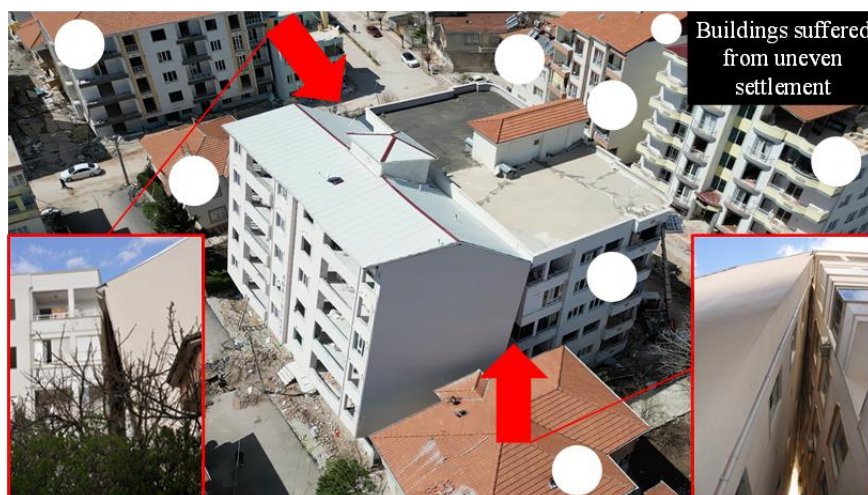
Figures 16, 17, 18 and 19 depict typical building damages. Figure 16 shows the most severely tilted building identified during the authors' survey, leaning against an adjacent structure. The groundwater level at the foundation of this building, which exhibited pronounced tilting, was approximately at ground level -1.0 meter.

Aerial imagery in Figure 16, captured from a northwest perspective, reveals significant subsidence and tilting damage affecting nearly all mid-rise buildings within the frame. Figure 17 features a building that experienced extensive settlement, subsiding by approximately 1.5 meters, causing cars to become wedged into the parking space's ceiling. Additionally, Figure 18 showcases notable settlement of mid-rise buildings on both sides of a narrow road, accompanied by substantial uplift of the road surface. These damages correspond to significant ground deformations, with minimal structural damage to walls and columns. However, Figure 19 illustrates a severely damaged building where the ground floor's walls and columns failed due to seismic motion, subsequently sinking into the soil. According to interviews with local residents, one building (green and white) reputedly had a pile foundation and incurred substantial settlement and tilting damage, as illustrated in Figure 19. Specifics regarding this building's pile foundation remain unclear at present.

Figure 16. Heavily tilted building and surrounding buildings with similar damage

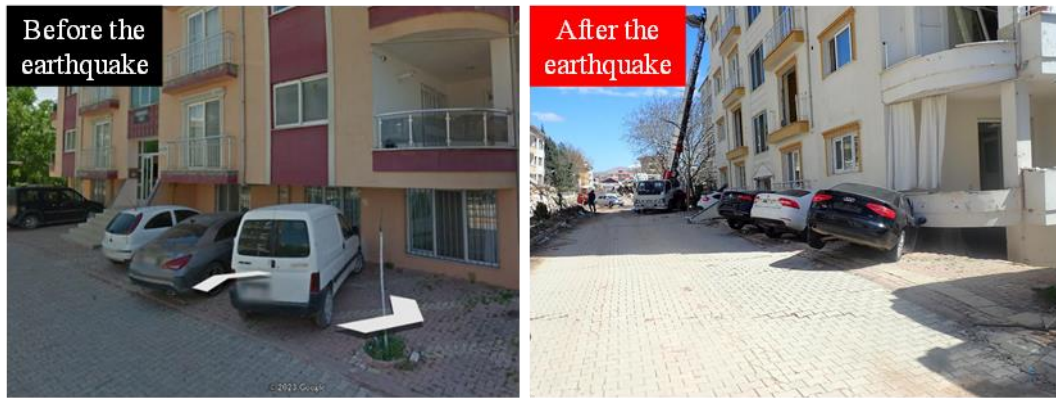
Figure 17. Building suffered from subsidence of about 1.5 m – before and after the earthquake

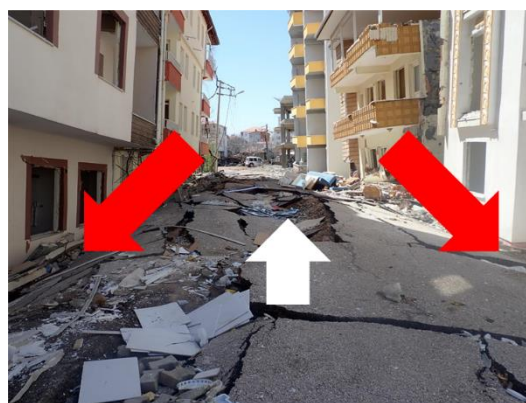
Figure 18. Road uplift and settlement / tilting damage to buildings on either side of the road

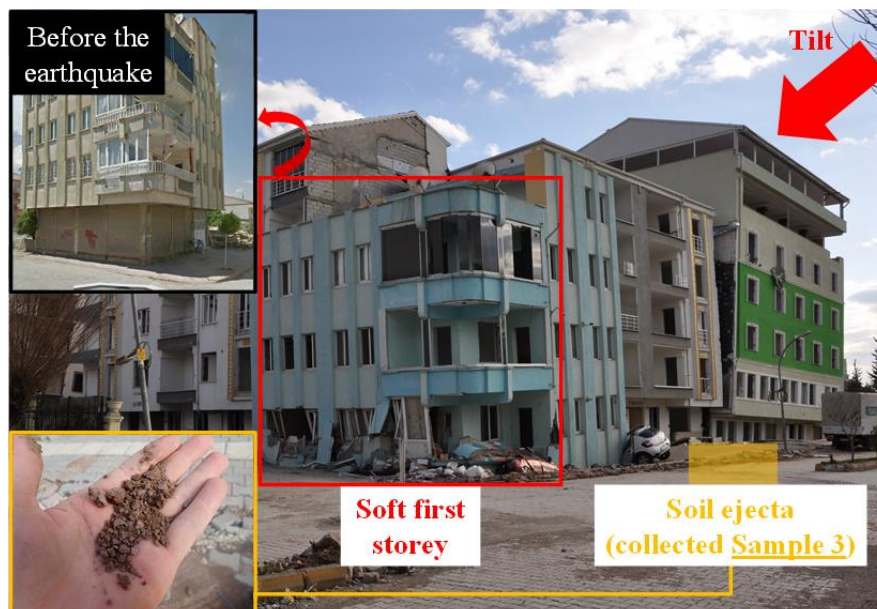
19. Structural damage (soft first storey) – blue building, and settlement / tilting damage of a building (green and white) that reportedly had pile foundations

Furthermore, the ejected soil collected near the green and white building in Figure 19 primarily consisted of reddish-colored silt and clay, characterized by a substantial plasticity index (PI) of 20. According to liquefaction assessment standards established by JRA and AIJ (REF), soils with a

plasticity index exceeding 15 are deemed unlikely to liquefy and are thus exempt from liquefaction analysis. This suggests that liquefaction may have taken place at the source of the ejected clayey soil, or alternatively, the surface clayey soil could have been entrained in the ejected water resulting from liquefaction in the underlying sand or gravelly soil layers, subsequently surfacing.
