## LANDSLIDE ON LOCATION OF WATER SOURCE STUDENAC NEAR BIJELJINA, REPUBLIKA SRPSKA

Durić Neđo<sup>1</sup>, Perisić Milan<sup>1</sup>, Đurić Dijana<sup>1</sup>

<sup>1</sup>Technical Institute Bijeljina, E.mail: [tehnicki@tehnicki-institut.com](mailto:tehnicki@tehnicki-institut.com)

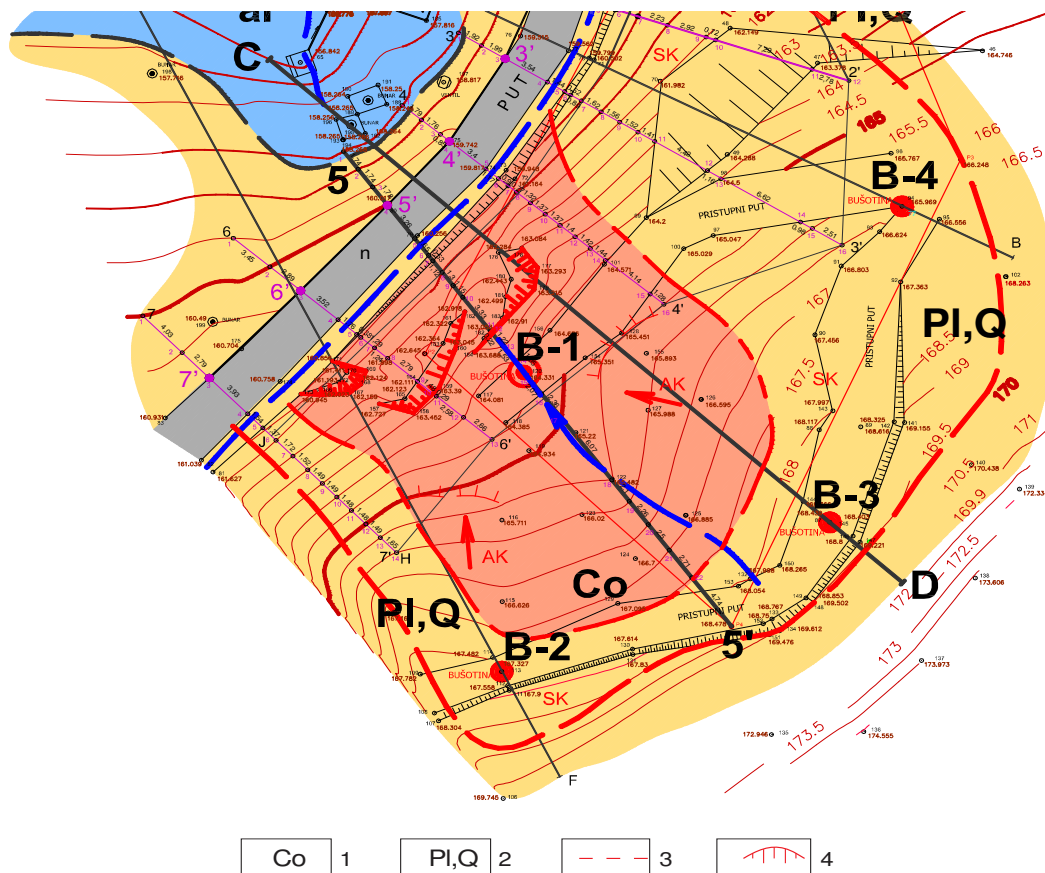
Picture 1. Engineering-geological map of the studied site

Colluvial sediments, 2. Pliocene-Quaternary sediments, 3. Landslide ridge, 4. Landslide scars

Forehead landslide scar is not clearly visible while the foot part is more obvious and it is positioned within the local road area. Landslide scars and fractures as well as bulges of slipped and re-deposited materials are registered in the main body of a landslip. Sliding scars are clearly visible in the foot area of the landslip, in clays of plastic medium that is separated from the bulk medium by thin bed of undetached material. That is the zone of maximal secondary tensions with the greatest deformations. The height of the scars ranges from 0,5 m to 1,5 m maximum. They are noticeable from the landslide toe and almost to the forehead scar.

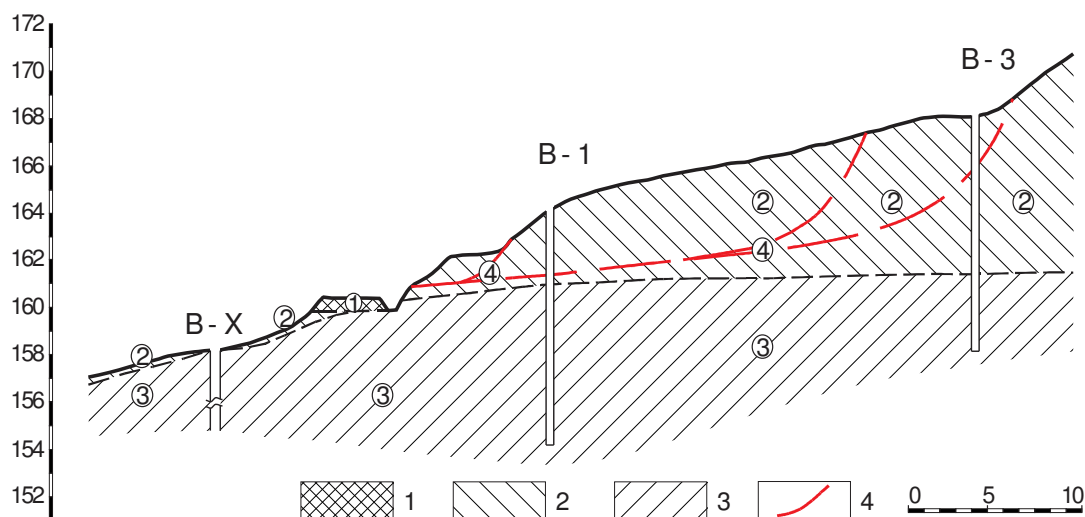
Picture 2 Geotechnical site profile C-D  
 1. Technogenic sediments, 2. Silty clay sediments (Cl, Cl-CH, CH),  
 3. Gravel sediments (GF), 4. Sliding plane

Sliding plane was formed at depth of 2,5 to 4 m, depending on site morphology, in clay of high plasticity (CG groups). The inclination of sliding plane in the forehead scar area is steep and further towards the toe it is very mild, up to  $7^{\circ}$ . Further landslide characteristics are as follows:

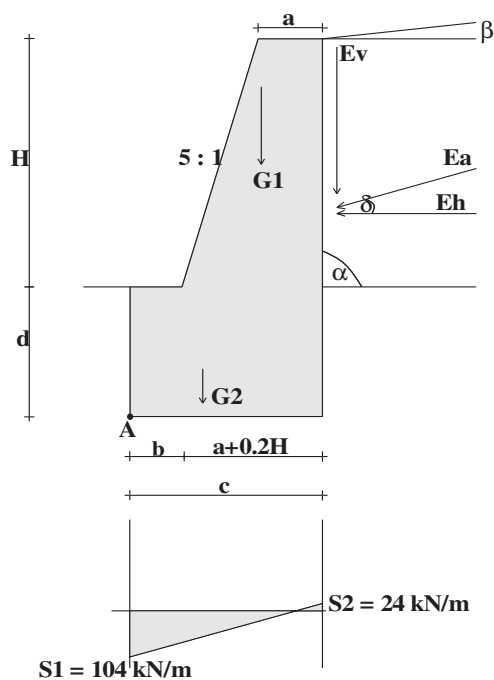
Picture 3. AB retaining wall at the profile 5 -5'

The analysis was conducted applying the Janbu method for polygonal slip plane. For the field conditions with underground water the obtained safety factor is  $F_s = 1,02$ , it is to say  $F_s \approx 1$  showing that the slope is unstable.

As a main restorative measure reinforced retaining AB wall made of concrete MB 25 was designed, protected from frost M – 100, picture 3. The wall is based in sandy gravel layer GC. Parameters selected for calculation are:

The wall has a function to accept the pressure of slipping soil mass and to prevent its sliding, namely to keep the slope in a stable condition. The length of the retaining wall is 50,0 m and it was founded on a substrate of sand-gravel formation (GC) throughout its entire length. In order to prevent the retention of water behind the wall, wholes were anticipated in the concrete ("barbakane"), diameter of 10 cm, two of them for each bay, picture 4. Water is further carried by gravitation to the open canal that is situated between the road and the wall.

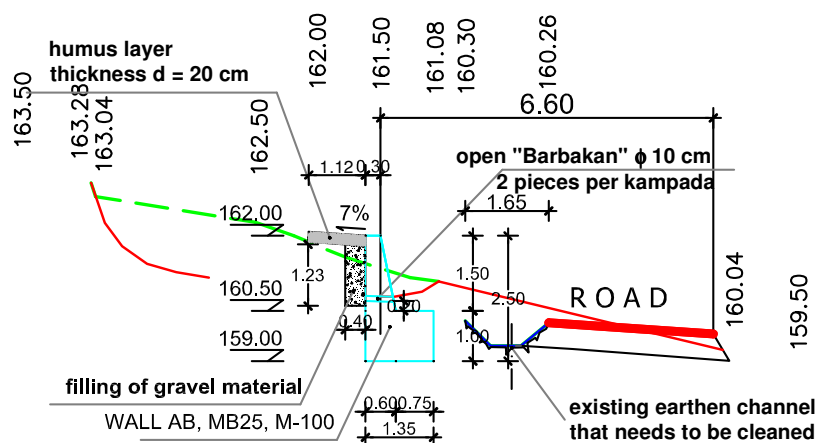
Picture 4. Transverse profile of the field and the retaining wall 5 – 5'

Analysis of the slope stability was done for the terrain conditions shown at the section 5 – 5' where embankment beds, clay and sandy gravel beds are present. Clays are the type CH and CI, fractured in the surface part and they can accept water that erodes their surfaces. Depth of the bed is from 2,0 to 8,0 m. Below the clay layer there is a substrate made of gravel soil GC. This layer is very resistant and suitable for foundation retaining structures. During the hydrologic maximum, it is possible that the level of underground water rises to the clay layer and then it presses and deforms the lower side.

The other remedial measure was construction of an open perimeter canal at the slope above the retaining wall for the purposes of collecting surface water flowing towards the main body of the landslide and its diversion outside the sliding area. Lining of the canal that remains in the ground is not provided but it requires frequent maintenance and cleaning as needed [7,8].

In order to prevent restorative works to cause new sliding and slope instability their dynamic was determined. Firstly, an open canal without lining was constructed to accept surface water at the slope above the retaining wall. Then excavation works and concreting of retaining wall were performed in planes of 4 m until the retaining wall was completely finished.
