LIQUEFACTION-INDUCED DAMAGE IN THE CITIES OF ISKENDERUN AND GOLBASI AFTER THE 2023 TURKEY EARTHQUAKE

Milev Nikolay¹, Takashi Kiyota², Briones Juan³, Briones Othon³, Cinicioglu Ozer⁵, Torisu Seda⁶

SUMMARY

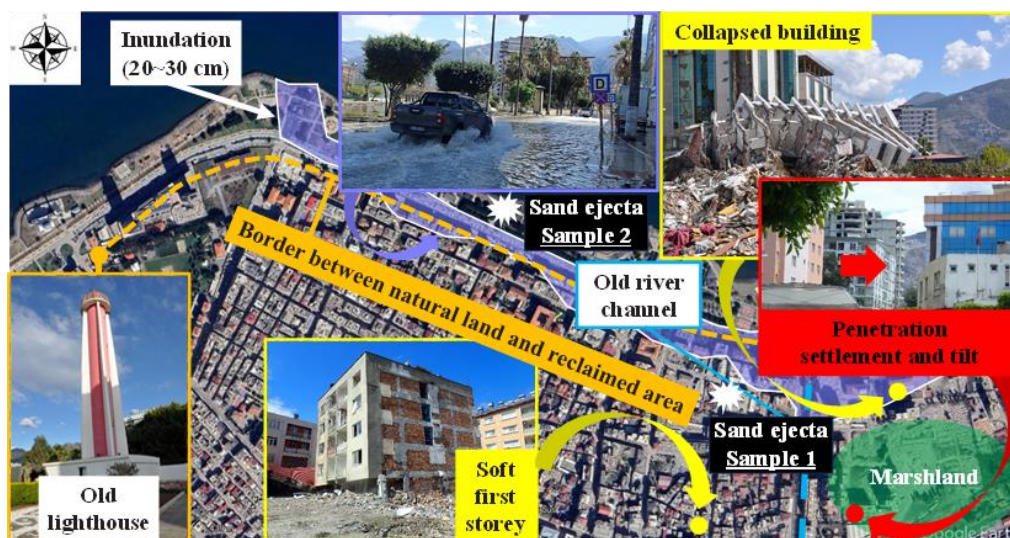
Figure 2. Reclaimed land boundary and inundation area in Iskenderun City observed in the authors' survey on 31st March, 2023

Figure 2 additionally illustrates damage caused by liquefaction, including slight building subsidence and significant sidewalk uplift. This street was previously a water channel [6], potentially making the reclaimed soil in the channel susceptible to liquefaction during the earthquake. Figure 3 and Figure 4 depict typical structural damage in Iskenderun. Figure 3 shows a mid-rise building in reclaimed land, where the entire structure has tilted significantly.

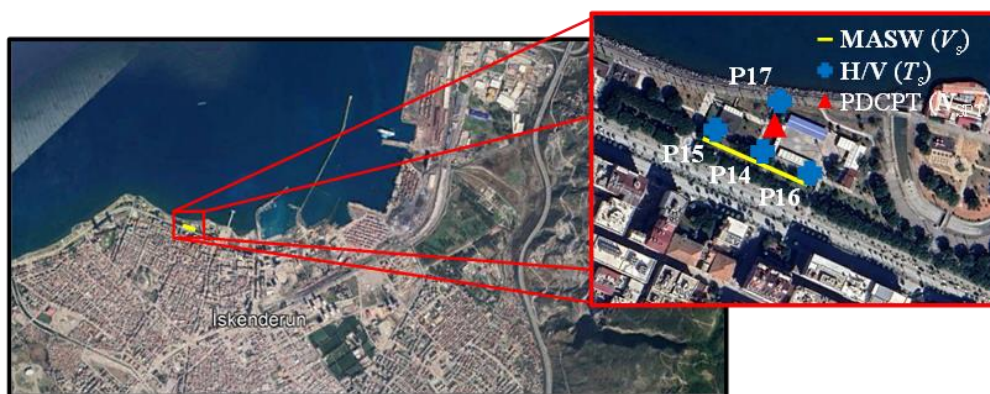
Figure 7. Location of performed tests in the city of Iskenderun (36°35'33.99"N, 36°10'6.98"E)

Figure 7 presents the exact location and Figure 11 results of the PDCPT at DP-3 and the multichannel analysis of surface wave (MASW) at SW-1. The PDCPT was conducted down to a depth of ground level -4.0 meters, revealing that the groundwater table was almost at the surface. The N_{SPT} values at the top surface were consistently low, less than 5, and slightly increased, ranging from 5 to 10, from ground level -1.0 meter to -2.0 meters. Below this depth, the soil layer exhibited loose characteristics, with N_{SPT} values averaging around 5. As shown in Figure 8, several cracks, each several tens of

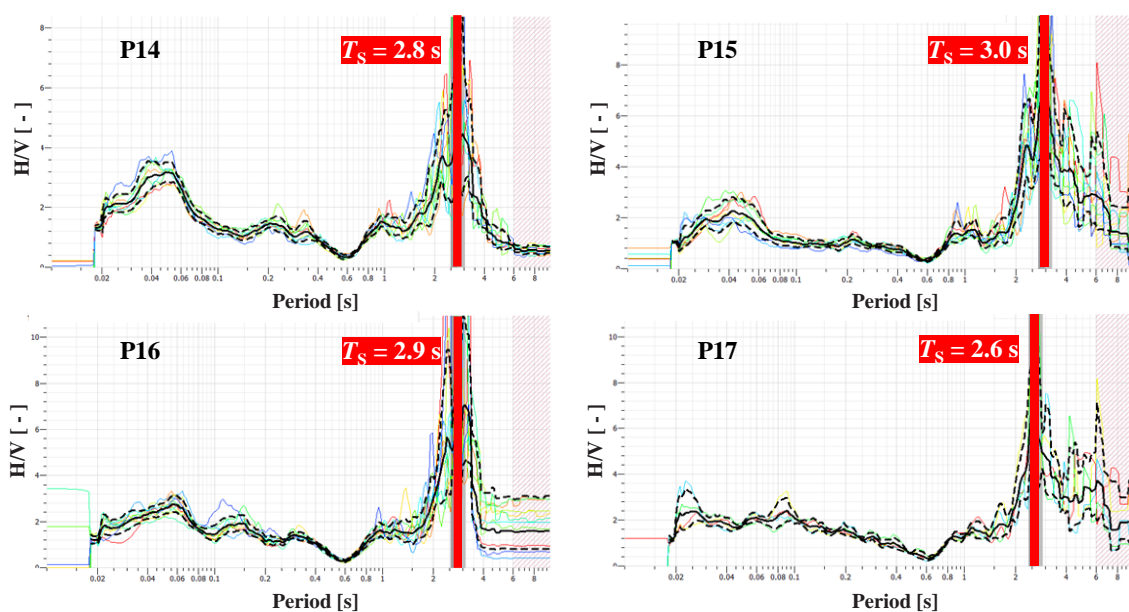
The shear wave velocity value of the surface layer from the MASW was consistently less than 150 m/s but gradually increased up to approximately ground level -10 meters, reaching about 190 m/s (Fig. 10). At greater depths, the shear wave velocity value remained relatively stable until about ground level - 25 meters. Given these findings, it can be reasonably concluded that the observed 50 cm subsidence along the shoreline was a result of liquefaction in the reclaimed ground up to approximately ground level -10 meters, especially considering the occurrence of lateral spreading. However, it should be noted that the inundation damage in Iskenderun City was more severe immediately after the earthquake. Further investigations are necessary to explore the causes of land subsidence in the city, which may not solely be attributed to liquefaction but also to crustal deformation effects.

Figure 9. Results from microtremor tests – evaluation of predominant period of the soil profile at P14, P15, P16 and P17

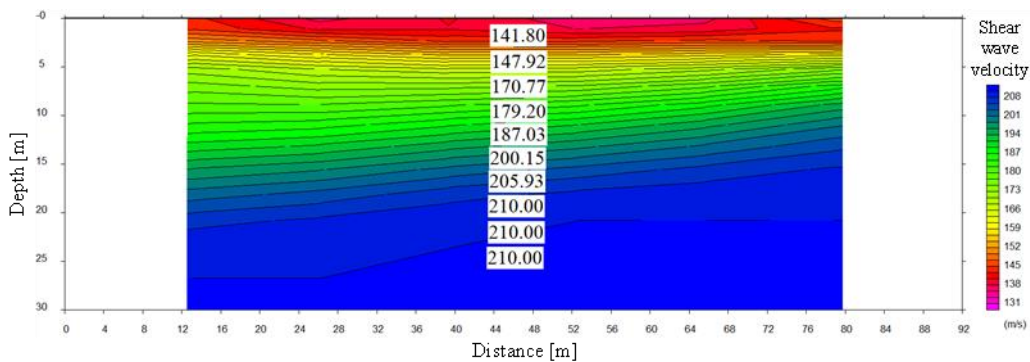
Figure 10. 2D shear wave velocity profile based on MASW measurements at SW-1

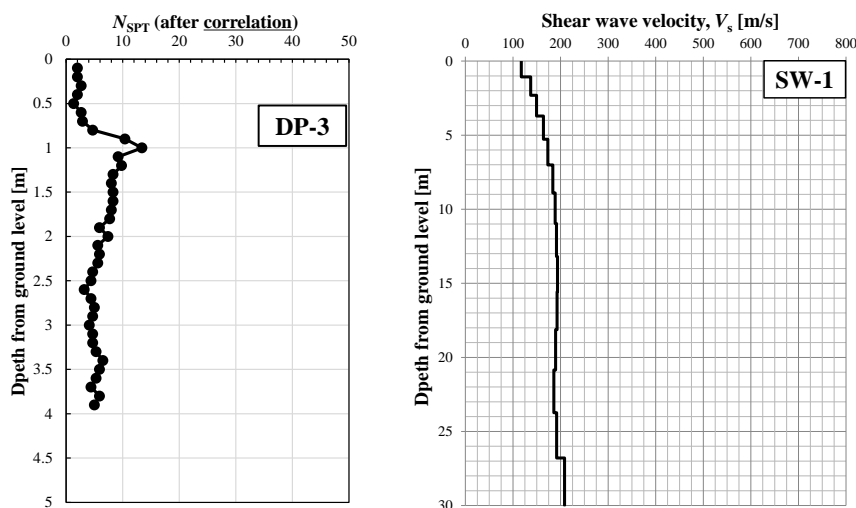
Figure 11. Results of PDCPT at DP-3 and MASW at SW-1

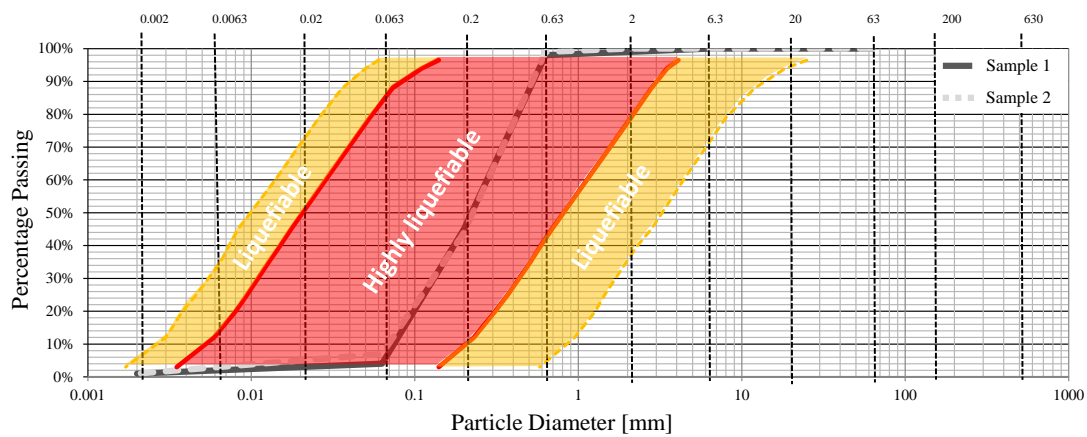
During this survey, two distinct soil samples, referred to as Sample 1 and Sample 2, were collected, with their specific locations illustrated in Figure 2. Both samples, identified as sand ejecta, exhibit a specific gravity of 2.68. Notably, the particle distribution curves for these samples are remarkably similar, characterizing them as poorly graded and “highly liquefiable” soils. Moreover, a thorough evaluation of site-specific soil characteristics to advance our understanding of seismic site response was conducted. Cutting-edge geophysical techniques for direct measurements of key parameters were utilized. The MASW method was employed to determine the shear wave velocity (V_{s30}), representing the average shear wave velocity in the upper 30 meters of the soil medium at the study site. Additionally, the microtremor-based horizontal-to-vertical spectral ratio (H/V) method was employed in order to derive the predominant period of the soil profile (T_s), resulting in an average T_s value of 2.8 seconds (Fig. 9). These measurements provided critical input parameters for further seismic hazard analysis. Based on this data, the average depth (H) to a stiff layer with a shear-wave velocity greater than 800 m/s within the soil profile was estimated using the classic formula $H = (4 \times V_{s30}) / T_s$ [7], resulting in an estimated H value of approximately 130 meters. These findings offer valuable insights into site-specific seismic response characteristics, crucial for seismic hazard assessment and infrastructure design in the studied region. According to Eurocode 8, the classification of a soil profile based on its shear wave velocity in the upper 30 meters (V_{s30}) is a fundamental step in assessing seismic hazard. When V_{s30} falls into the Type D category, it indicates that the soil profile consists of relatively soft and potentially liquefiable soils. This classification holds significant implications for seismic risk assessment and structural design since Type D soil profiles are associated with increased ground motion amplification and heightened seismic vulnerability.

Figure 13. Particle distribution curves of sand ejecta (Sample 1 and Sample 2) collected from the city of Iskenderun – comparison with critical range associated with liquefaction

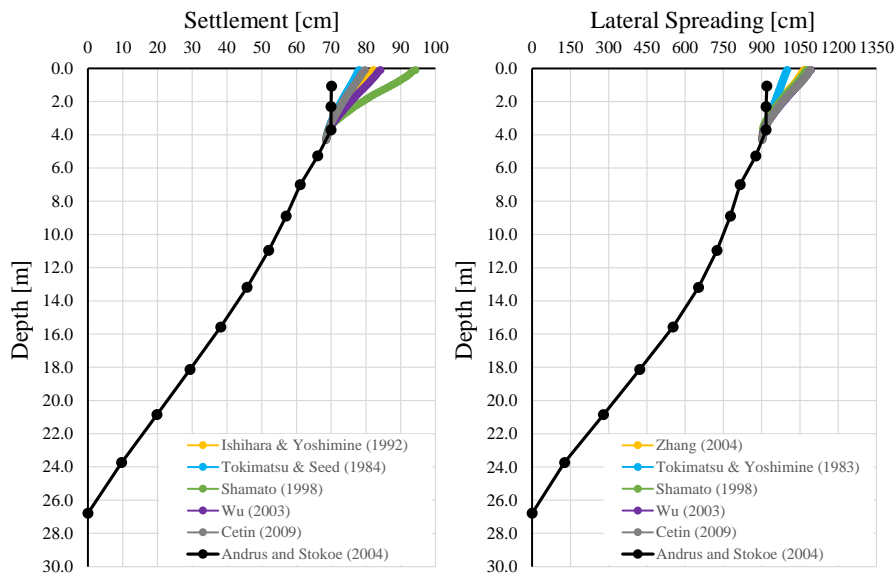
Liquefaction assessment within this study adhered to a robust deterministic framework, combining crucial data from two primary sources: 1) results obtained through PDCPT, converted to N_{SPT} [8,9, 10], and 2) shear wave velocity (V_s) profile [11,12]). The calculated factor of safety (FS) consistently revealed values below unity, indicating the susceptibility of the soil profile to liquefaction-induced

phenomena. This susceptibility necessitated a meticulous examination of potential consequences, encompassing liquefaction-induced reconsolidation settlement and lateral spreading phenomena [13,14,15,16,17,18,19]. The results, as presented in Figure 13, portray a conservative outlook on the liquefaction potential. However, it is imperative to exercise discernment in interpreting these findings. Some layers within the soil profile may exhibit relatively low V_s values, potentially raising concerns regarding their liquefaction susceptibility. Nonetheless, a profound understanding of the physical properties (especially particle size distribution curve and plasticity parameters) of these specific layers might mitigate these concerns. Their intrinsic characteristics, such as high confining pressures, significant fines content, or cementation, effectively preclude them from active participation in the liquefaction response. Thus, the comprehensive liquefaction assessment underscores the importance of considering not only the quantitative data but also the qualitative aspects of soil behavior, ensuring a holistic understanding of site-specific seismic risk. Such knowledge is invaluable for seismic hazard assessment and resilient infrastructure design in the region.

Figure 13. Evaluation of settlement and lateral spreading due to possible re-liquefaction in the city of Iskenderun by simplified procedures

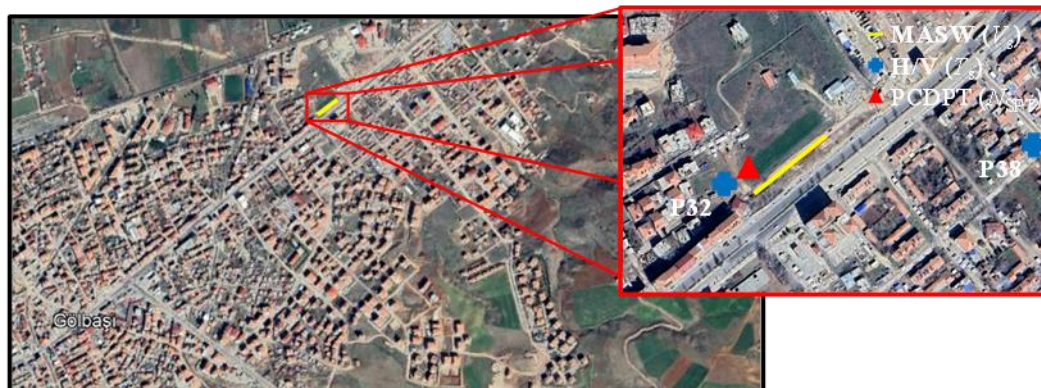
Figure 20 and Figure 21 display the locations and Figure 23 demonstrates the results of PDCPT (PD-4) and MASW (SW-2) assessments conducted near a heavily subsided and tilted building. The N_{SPT} values were exceptionally low, registering less than 5 up to ground level -3.0 meters and gradually increasing beyond that depth. Conversely, the shear wave velocity values exhibited minimal values of 130-140 m/s up to ground level - 7.0 meters, followed by a slight increase with depth. Loose soils extended continuously down to ground level - 20 to - 25 meters. These findings suggest that the shallow surface soil layer, characterized by liquefaction and loss of bearing capacity, led to considerable settlement and tilting in structures. Borehole data from the city of Golbasi has been analyzed [20], revealing that the lake-side region adjacent to the main road (D360) predominantly comprised soft clay. Nevertheless, same study also identifies pockets of medium-dense sand and gravelly soils, which align relatively closely with the area demarcated by the broken line in Figure 14. This implies that significant liquefaction may have occurred in these medium-dense sand or gravelly soil sections.

Figure 20. Location of performed tests in the town of Golbasi ($37^{\circ}47'26.57''N$, $37^{\circ}39'7.88''E$)

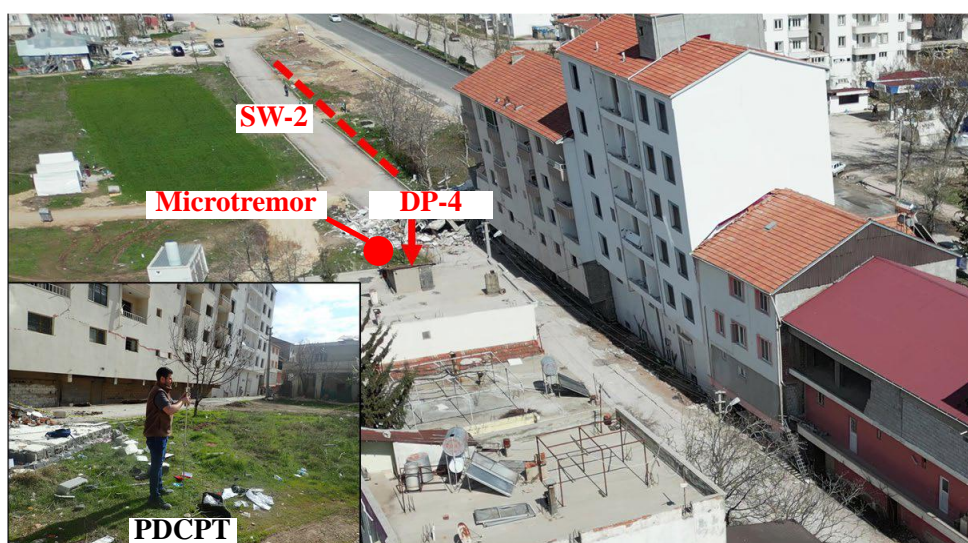
While this survey included PDCPT and MASW evaluations conducted immediately adjacent to the main road, confirming the thickness of the soft surface layer, it is conceivable that the thickness of the soft layer may increase closer to the lake. Additionally, subsidence and tilting damage to buildings resulting from ground deformation were observed on the western boundary of Golbasi, as indicated on the map in Figure 14. Consequently, further investigations are imperative to ascertain the liquefied soil layer and its distribution in the future. Figure 24 illustrates particle size distributions for soils typically associated with liquefaction, and the envelope of soil considered susceptible to liquefaction [21]. Samples from soil ejecta were collected right next to green and white building on Figure 19, and particle size tests were conducted in the laboratory. The resulting particle size distribution curve was then compared to the particle size distributions for soils typically associated with liquefaction. It is evident that a significant portion of the curve falls within the “highly liquefiable” region. Moreover, the evaluation of liquefaction susceptibility incorporates three established procedures: those proposed by [22,23] and the criteria outlined in the Japanese Road Bridge Design Standards. These methods are based on analyzing fundamental physical soil properties, including the Plastic Index (PI), Liquid Limit (LL), and Fines Content (FC). According to these simplified assessment techniques, the soil in the Golbasi region is classified as “moderately susceptible to liquefaction” – Figure. 25 and Figure. 26. This categorization is critical, emphasizing the need for vigilance, especially given the severe damages in Golbasi associated with such soil classifications.

Figure 21. Locations of PDCPT, MASW and microtremor measurement conducted near buildings with subsidence / tilting damage ($37^{\circ}47'26.57''N$, $37^{\circ}39'7.88''E$)

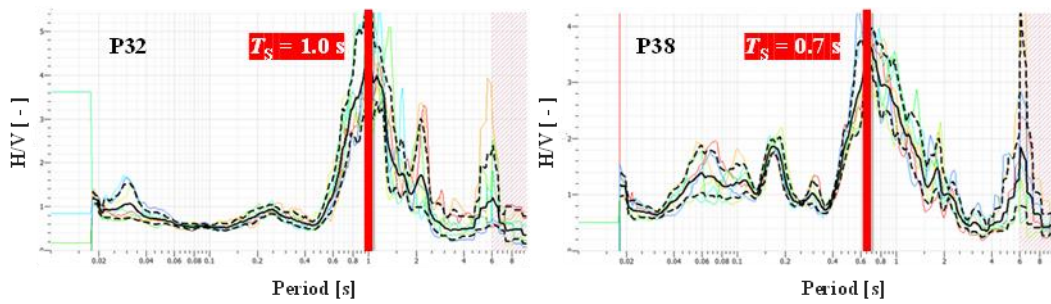
Figure 22. Results from microtremor tests – evaluation of predominant period of the soil profile at P32 and P38

In parallel measurements conducted in the city of Iskenderun, a similar suite of tests to assess site-specific soil characteristics was employed. The shear wave velocity (V_{s30}) in Golbasi was determined to be approximately 170 m/s, and the predominant period of the soil profile (T_s) was measured at 1.0 second, with a specific focus on point P32, a location associated with numerous liquefaction occurrences (Figure 22). The estimated depth (H) to a stiff layer with a shear-wave velocity exceeding 800 m/s within the soil profile was found to be around 43 meters. The outcome of this evaluation led to the categorization of the soil as Type D in the context of Eurocode 8, indicating the existence of relatively soft and potentially liquefiable soils. This classification holds notable consequences for seismic risk assessment and structural design, primarily due to the elevated levels of ground motion amplification and heightened seismic vulnerability typically associated with Type D soil profiles.

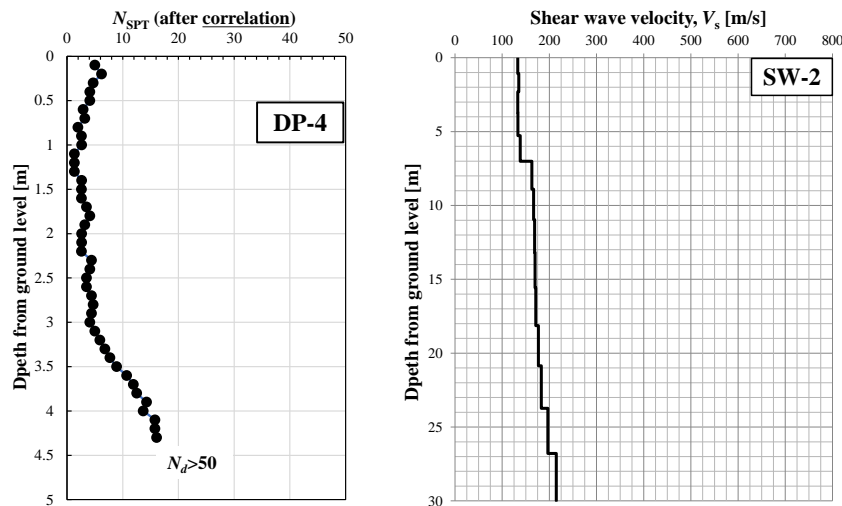
Figure 23. Results of PDCPT at DP-4 and MASW at SW-2

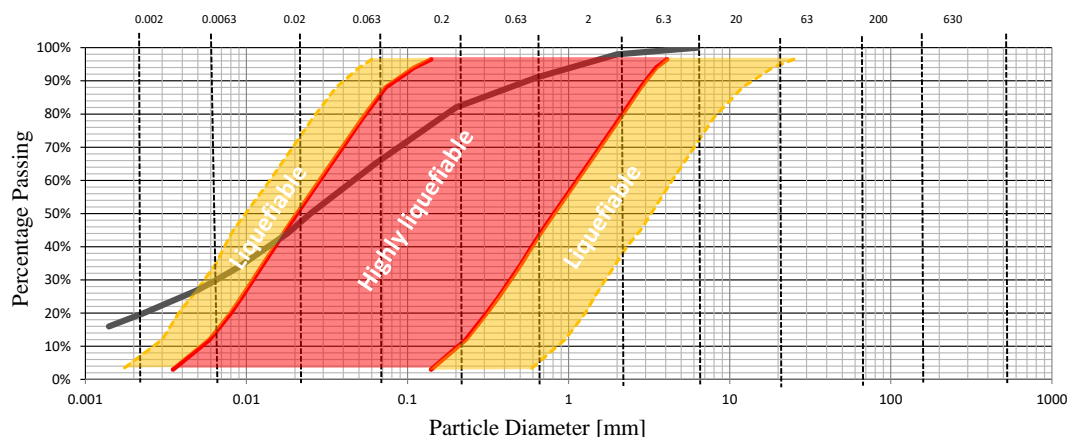
Figure 24. Particle distribution curve of soil ejecta (Sample 3) collected from the town of Golbasi – comparison with critical range associated with liquefaction

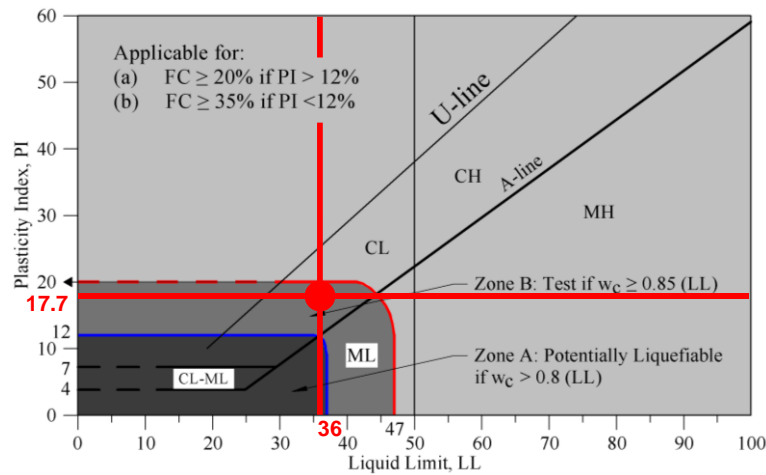
Figure 25. Sample 3 (Golbasi soil ejecta): Liquefaction susceptibility evaluation by adopting the procedure of (Seed et al., 2003)

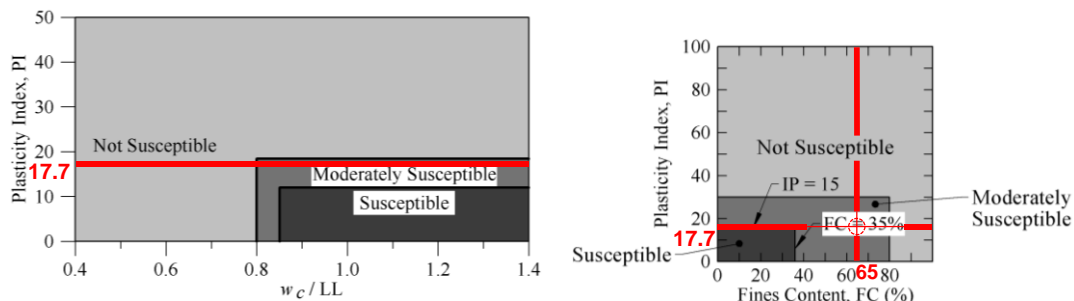
Figure 26. Sample 3 (Golbasi soil ejecta): Liquefaction susceptibility evaluation by adopting the procedure of (Bray & Sancio, 2008), left, and Japanese Road Bridge Design Standards, right

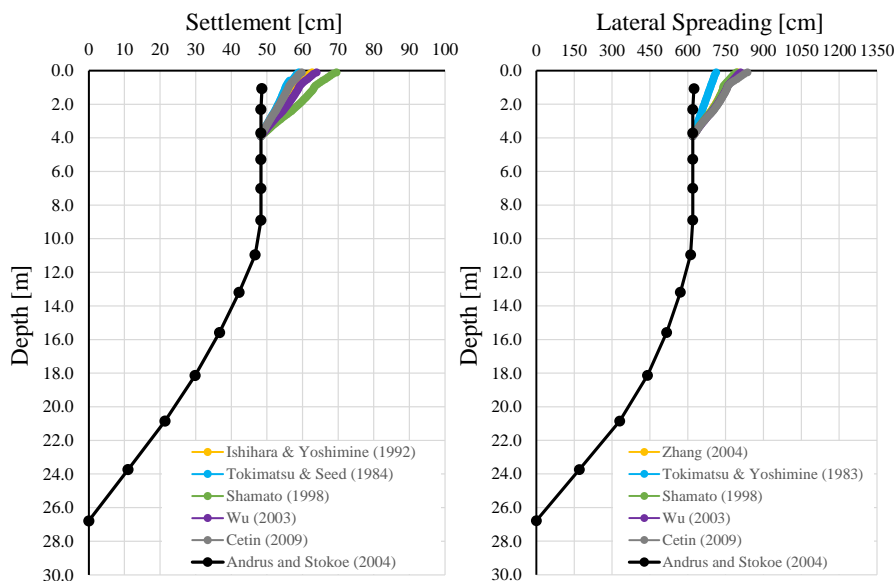
The calculations for the Golbasi site mirrored those for Iskenderun, reaffirming the re-liquefiable nature of the site with a factor of safety (FS) consistently below 1.0, following the deterministic approach. This comprehensive assessment encompassed the evaluation of potential liquefaction-induced reconsolidation settlement and lateral spreading (Figure. 27). It is worth emphasizing that the obtained values, while relatively substantial, stem from the limited knowledge of the soil's physical properties. Nonetheless, these cautious estimations emphasize the imperative for more in-depth investigations.

Figure 27. Evaluation of settlement and lateral spreading due to possible re-liquefaction in the town of Golbasi by simplified procedures

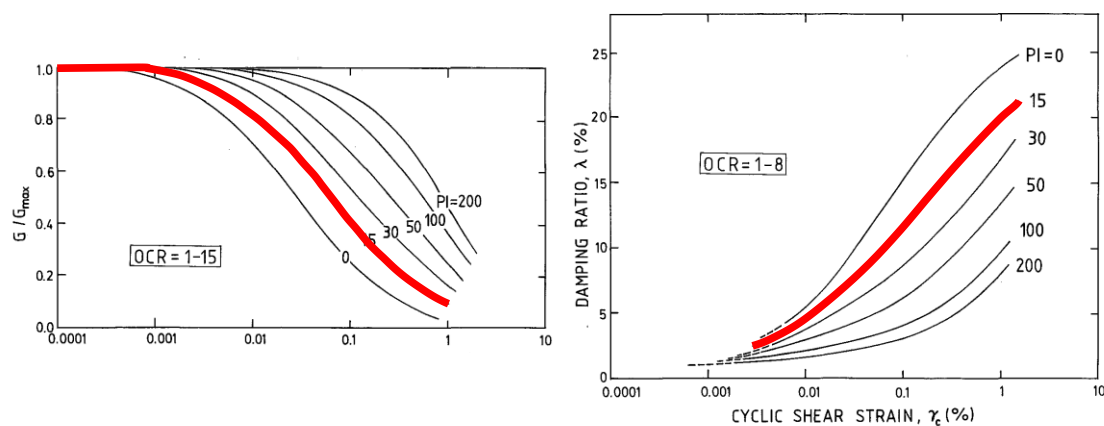
The collection of soil samples and the subsequent determination of their physical properties represent a significant step towards a more comprehensive understanding of the geotechnical characteristics in the affected regions. Notably, the determination of a plasticity index (PI) within the range of 15 to 20 provides valuable insights into the soil's behavior under seismic loading conditions. Moreover, with direct measurements of average shear wave velocity (V_{s30}) using the multichannel analysis of surface waves (MASW) method and the assumed bulk density (ρ) in the range of 1800 to 2000 kg/m³, it becomes possible to make preliminary estimations of critical parameters. One such parameter is G_{max} , the maximum shear modulus of the soil ejecta, which equals the product of bulk density and shear wave velocity squared, resulting in G_{max} values ranging from 50 to 55 MPa in this context ($G_{max} = \rho \times V_s^2$). Drawing from the work of [24], stiffness degradation curves and damping ratios can be roughly assumed, further enhancing our capacity to model the soil response during seismic events (Figure. 28).

Figure 28. Assumed stiffness degradation and damping ratio in relation with shear strain – tested soil ejecta – after [24]
